Mariusz Piotr HETMAŃCZYK, Jerzy ŚWIDER  
Politechnika Śląska

## **ANALYSIS OF THE CONDITION OF CAR DAMPERS ON THE BASIS OF IDENTIFICATION OF THE PARAMETERS OF FFT SPECTRUMS**

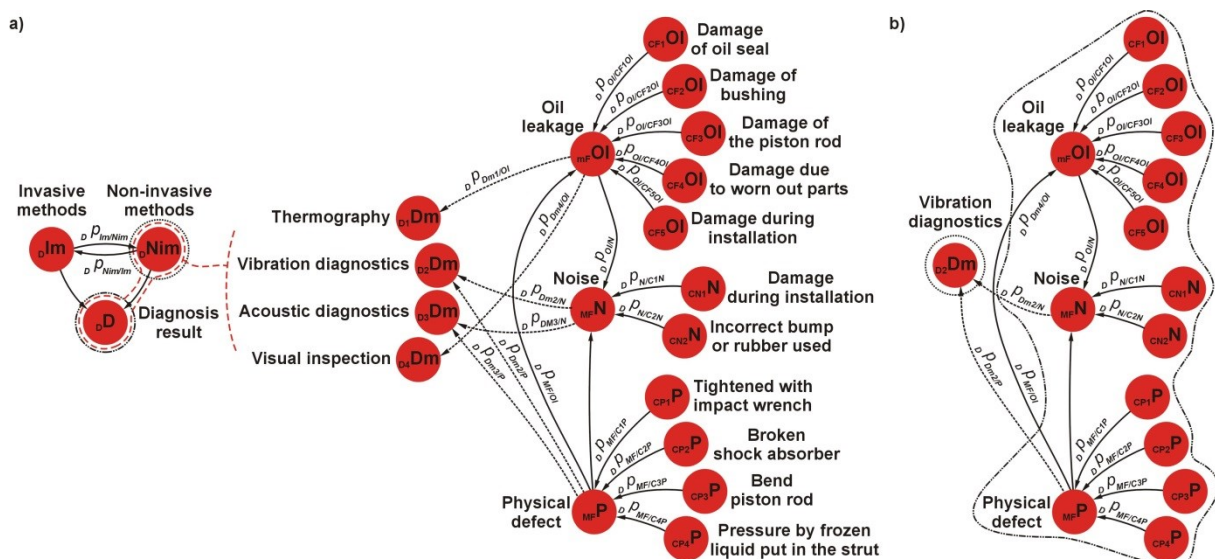
Fig. 1. Cause and effect graph of the damages and irregularities and their path of development for the case of the damper base valve unit: a) complete graph, b) graph after reduction

Table 1 presents the basic types of car damper damages that lead to irregularities in performance presented in figure 1. The damage connected with operation (such as broken springs or wear of McPherson strut bearings) have been disregarded due to their classification to the group of operating damage. On the basis of the presented damages, a graph of damages propagation of car dampers has been prepared (Fig. 1).

The identified graph constitutes the formal notation of the error development path. However, the main task is the identification of the peak corresponding to the current condition of the examined unit. The selected mechanical subsystem enables the identification of damage on the basis of the frequency spectra analysis.
